# POTOMAC RIVER BASIN

Name of Dam: Dry Run No. 101

Location: Page County, State of Virginia

## PHASE I INSPECTION REPORT NATIONAL DAM SAFETY PROGRAM

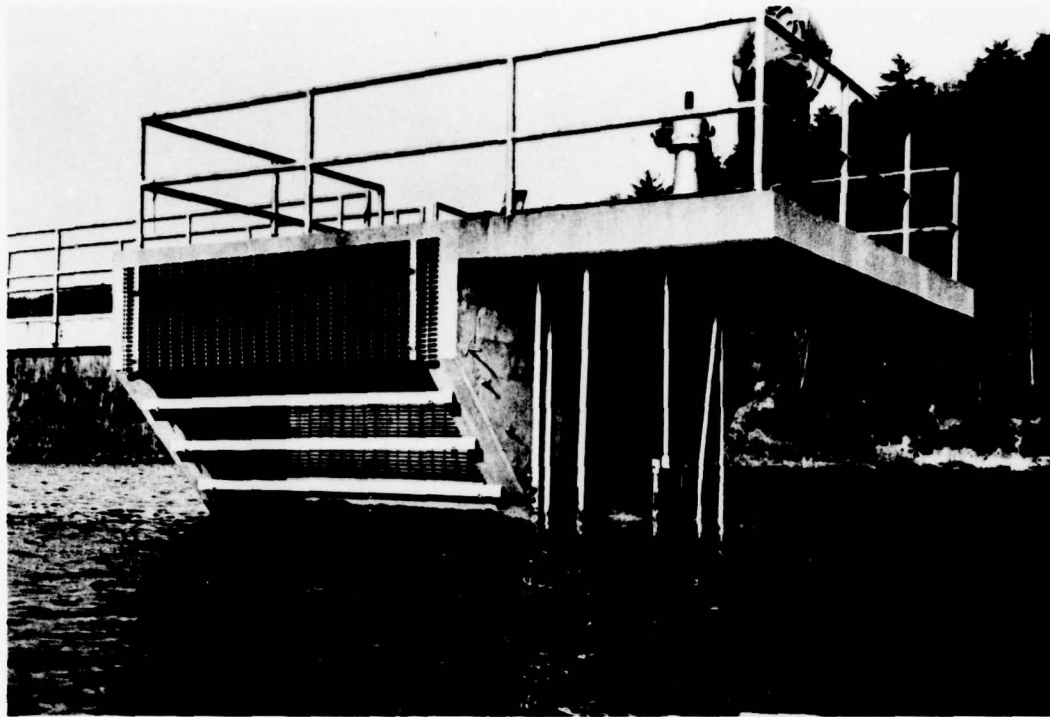
- 3.1.3 Appurtenant Structures: Several of the stems to the water supply gates are disconnected or bent (see Photo 1) and would need to be repaired before they could be used for water supply.

**PHOTO 1. Riser's Lift Pedestal, Gate Stems and High Stage Trash Rack**

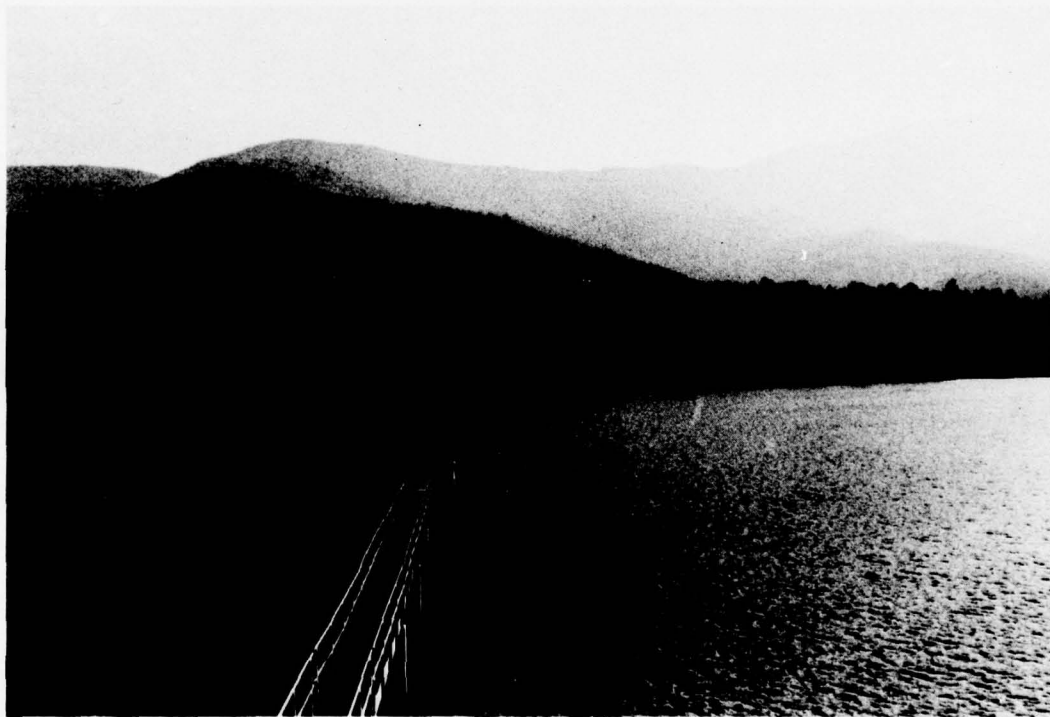
- 3.1.4 Reservoir Area: No serious deficiencies were observed in the reservoir area (see Photos 2 and 3). A staff gage should be installed to monitor reservoir elevations above normal pool.

**PHOTO 2. Reservoir Area and Riser**

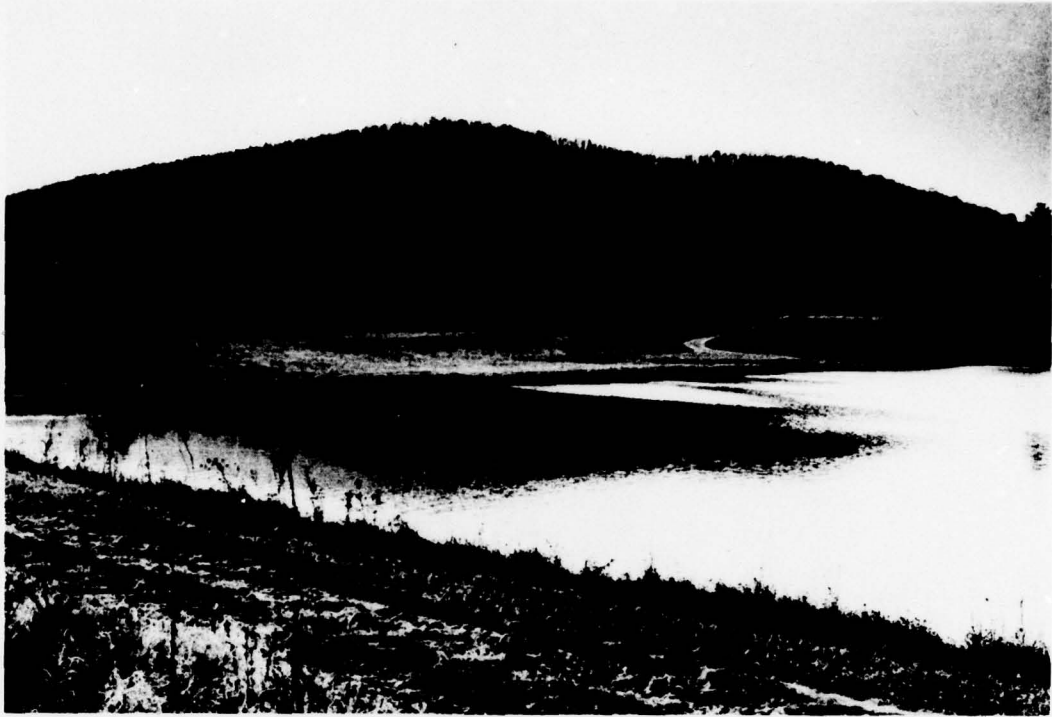
**PHOTO 3. Emergency Spillway in Left Abutment**
